## CNN-based classification of scale deposits and damages in drainage pipes using a mobile inspection rover

*Veronika Putz<sup>1</sup>, Christina Hofer<sup>1</sup>, Sabrina Fleischanderl<sup>1</sup>, Leander B. Hörmann<sup>1</sup>,  
Johannes Schröck<sup>1</sup>, Wolfgang Hofer<sup>1</sup>, Harald Hölzl<sup>2</sup>, Tobias Schachinger<sup>2</sup>, Vesna Micic Batka<sup>2</sup>*  
<sup>1</sup>Linz Center of Mechatronics GmbH, Altenberger Straße 69, A-4040 Linz  
<sup>2</sup>ÖBB-Infrastruktur AG, Praterstern 3, A-1020 Wien

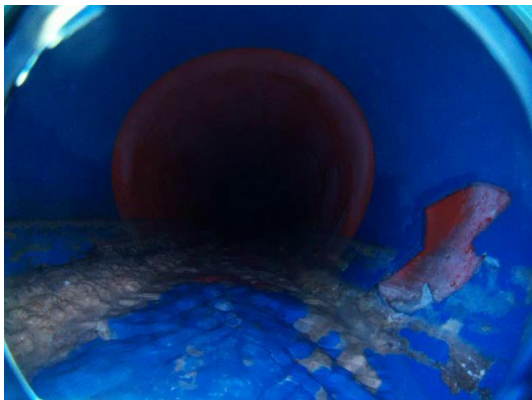
*Figure 2: Medium to severe scaling, visible hole in the pipe wall*

The structure and appearance of scale deposits can considerably vary, depending on their chemical composition [1]. Additionally, the color of the pipe material and the shape of the cross section of the pipe (circular, flattened) can differ in the field. The video material available from the experiments carried out covers various scenarios. Some examples are shown in Figures 2 to 5. Figure 2 shows a pipe made of blue thermoplastic material, partially filled with water, with scaling as well as a hole in the pipe wall visible on the right. Figure 3 shows a similar scene with more severe scaling in a pipe with reddish-brown walls.

A different scenario with severe scaling as well as formation of algae is shown in Figure 4, while Figure 5 contains isolated scaling occurring only at one side wall of the pipe. Note that Figures 4 and 5 were recorded using the high-quality external camera, while Figures 2 and 3 were recorded using the low-quality camera integrated in the sensor lance.

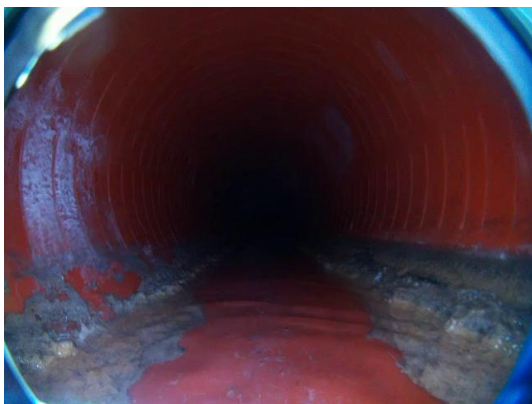
*Figure 3: Medium to severe scaling at the bottom, slight scaling at the side wall*

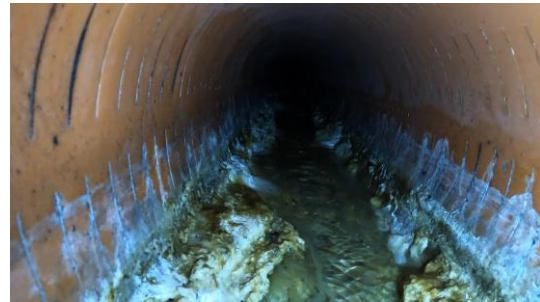
*Figure 4: Medium to strong scaling at the bottom, formation of algae*

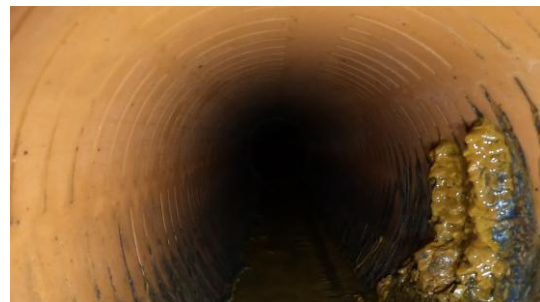
*Figure 5: Strong scaling with reddish color at the side wall of the pipe*

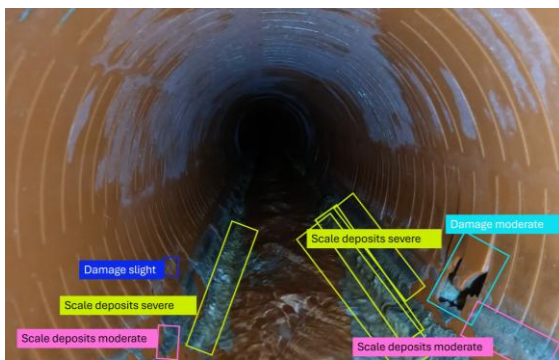
Figure 9 shows a sample video frame with the defects detected by the CNN marked as overlay. The benefit of the method, compared to VGG16, is obvious: The ability to detect multiple errors per video frame leads to an improved assessment of the overall area of the drainage pipe affected by scaling or damage within the image, which could not have been provided using the simple classification obtained from VGG16.

Figure 9: Video frame with detected artifacts from various classes

For the planning of maintenance measures based on recorded videos, raw detections of scaling and damage (as visible in Figure 9 for a single video frame) need to be further processed to provide an easy-to-read indicator for maintenance planning. A metric that visualizes the condition of an inspected section of the drainage pipe is required.

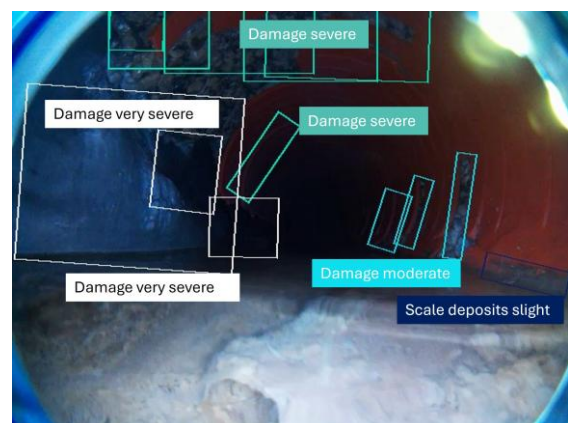
The obtained indicators are validated using an example image: In Figure 10, between 7 and 8 seconds after starting the experiment, a larger density of detected errors can be seen. Figure 11 shows a video frame recorded between these timestamps with the obtained detections of the CNN marked using color-coded bounding boxes, with many visible defects.

Figure 11: Sample video frame with many detections

Comparing the evaluations in Figure 10 and Figure 12 as well as video frames shown in Figure 11 and Figure 13, the difference is obvious. By evaluating the frame-by-frame detections as time-series signal, an easy-to-read indicator for the state of a drainage segment can be obtained. Similar evaluations are feasible for each individual error class, which would allow different treatment, e.g., of severe damage and scaling and less severe error classes.
