Microstructural investigations of blackening in YSZ sensors for hydrogen coulometry

A detailed microstructural analysis of a coulometric hydrogen sensor after operation at high electrical load is presented. The sensor is based on YSZ ceramic tube with outer and inner electrodes. Oxygen diffusion at grain boundaries under chemical and electrical potential leads to color changes (blackening), crack formation at the grain boundaries and phase transitions in the YSZ ceramic from cubic to monocline. These findings can explain an irreversible degradation mechanism of the solid electrolyte sensor.

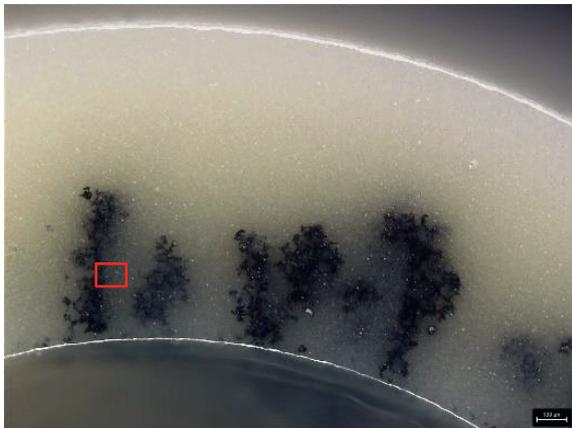
Fig. 1 Light microscope image of mechanical cross section of the YSZ tube. Blackening is visible in the YSZ ceramic starting at inner surface.

could be observed at the electrodes of the inner tube part. In addition, at some positions the blackening reaches the outer surface of the tube indicating possible sites for gas leakage and electrical shorts (Fig.1).

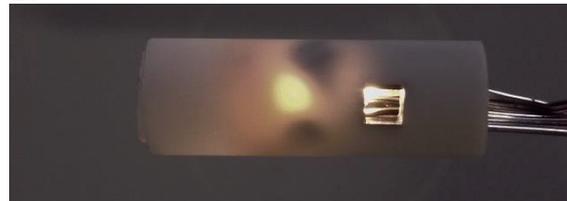
Fig. 3. **A.** Overview of the YSZ tube with electrodes. **B.** Part of the ceramic tube with inside illumination at the electrode position. Blackening inside the tube is visible.

In reduction atmosphere the color of the YSZ changes from opaque to black known as blackening-effect [1]. The blackening is a local phenomenon and could indicate the sites of the morphological and electrical failure of the sensor. Microstructural investigations were performed at sites of visible blackening (Fig.3). The localized areas were separated by sawing to get cross sections of the YSZ tube. Blackening
