# Detection of initial subsurface defects in rotor blade leading edges of wind turbines by means of active thermography

*Friederike Jensen<sup>1</sup>, Michael Sorg<sup>1</sup>, Andreas Fischer<sup>1</sup>*

<sup>1</sup> *University of Bremen, Bremen Institute for Metrology, Automation and Quality Science  
Linzer Str. 13, 28359, Bremen, Germany*

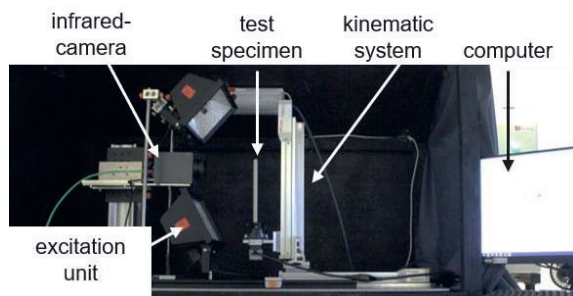
Fig. 2. Experimental setup for the thermographic examination of test specimens

For the thermographic investigations, a test rig is set up as shown in Figure 2. The test specimen, which resembles the leading edge of a rotor blade, is fixed in a kinematic system. Using a camera of the type Vario Cam hr head (resolution: 640 x 480 px, wavelength range: 7.5 – 14  $\mu\text{m}$ ) from the company InfraTec with a 30 mm lens, an image of the emitted infrared light from

the test specimen surface is obtained. Furthermore, an excitation unit, consisting of two 1 kW halogen lamps, is applied under and above the camera to heat the test specimen. The kinematic system as well as the IR camera is connected to a computer to position the test specimen and to evaluate the acquired image data with the software Irbis3 from the company InfraTec. For the examination the test specimen is excited for 10 s. The recording time starts at the end of the excitation and is set to 30 s at a recording frequency of 25 Hz. Here, the first image of the raw data is considered and processed with low pass filters to identify subsurface defects.

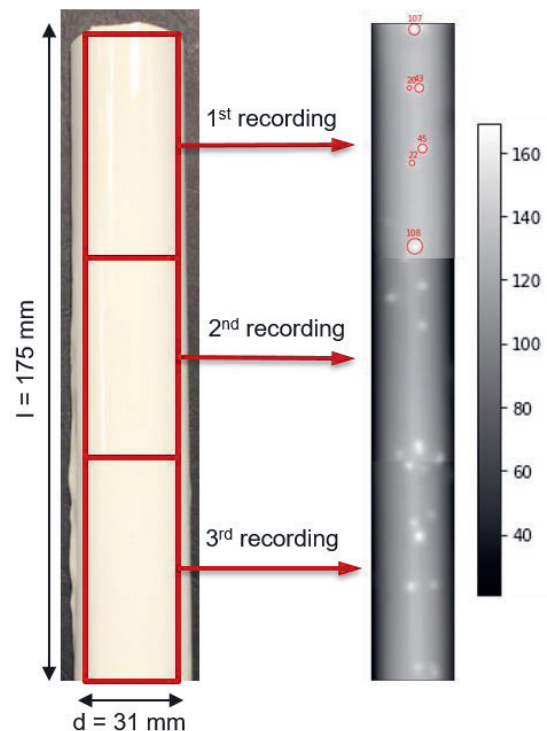
Fig. 3. Left: optical image of the modified test specimen; right: thermograms of the modified test specimen spread over three images – polystyrene balls are recognizable as bright points in the signal processed thermograms (marked with red circles and the corresponding CNR in the 1<sup>st</sup> recording as an example)

The measurements are carried out on a test specimen consisting of a hand-laminated GFRP half pipe which is covered with a coating system including a filler and a gel coating, both consisting of polyurethane. Polystyrene balls of an average diameter of 1 mm are incorporated into the coating system, which are intended to imitate air traps created during production. Figure 3 shows an image of the test specimen with its associated thermogram. Due to the prevailing temperature difference, which is caused during the cooling process by material-dependent heat storage capacities and the resulting different heat transfers, the small polystyrene balls are detected. They are recognizable as bright points in the thermograms, but remain hidden in the photograph. The CNR indicates the level of contrast between a defect and its surroundings. A high CNR stands for a high detection capability. Exemplary in the first recording, the CNR ranges between 22 and 108.
