Through this work, the interaction between the coating material pebax and the wire insulation is to be investigated. Afterwards its applicability should be evaluated for the mentioned guide wire.

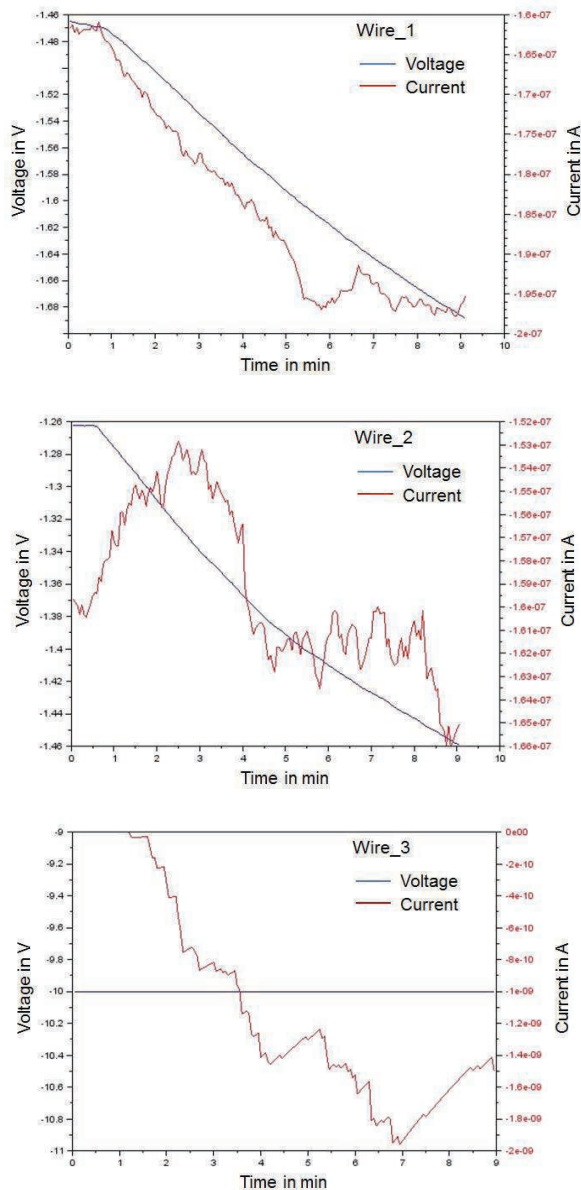
Fig. 6: Current-Voltage diagrams of copper wires during galvanization

In order to evaluate the influence of pebax coating on the wiring, the current-voltage curve was recorded. In Figure 6 the current-voltage diagrams of the copper wires, shown in Figure 5 during the galvanizing are given. By the

current-voltage diagrams the damage of the wire insulation revealed in Experiment 1 could be confirmed.

As expected, the measured voltage in wire_1 was higher than in wire_2. The reason is that the wire insulation of both wires was damaged differently, due to the different duration of the immersion. The voltage increase over the time (see Figure 6, wire_1 and wire_2) can be explained by the deposited nickel layer on the damaged areas. Wire_3 voltage couldn't be measured because the wire insulation is intact.

From the current-voltage diagram it can be seen that depending of the immersing time pure HFIP solvent caused damage to the sensor wiring. From the short time of immersion in the dissolved pebax the insulation of the copper wires was not damaged. In this study it could be proved that pebax 3533 can be used as a coating material for medical guide wires.
